U.S. ENVIRONMENTAL PROTECTION AGENCY - REGION 6
FINDINGS OF VIOLATION, COMPLIANCE ORDER, AND INFORMATION DEMAND
In the Matter of Creed Operating Company, LLC (Respondent)
Docket No. CWA-06-2013-1724

INSPECTION REPORT

Creed Operating Facility Co., LLC

Subject: Novice Unit Lease RRC 10904 Discharges to tributary and Jim Ned Creek (Point of Entries)

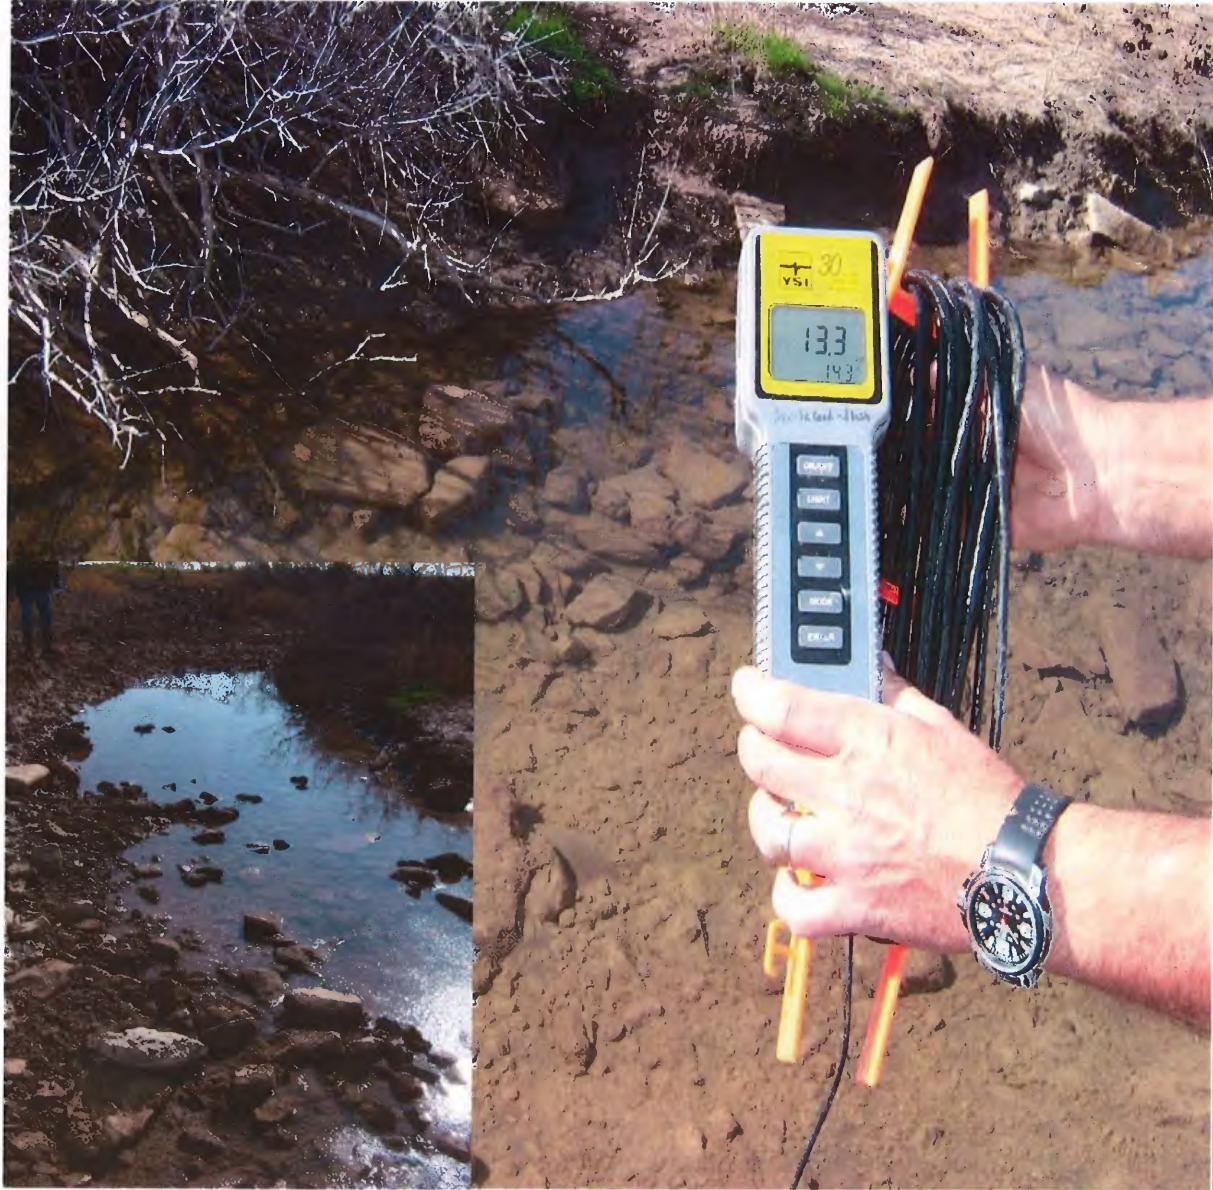
Creed Operating Facility Co., LLC Photo 18

Photo #18. Facing south east from point of entry to Need Creek and east from train rail. TSS measurement of standing fluids was 13300 ppm TSS. Did not observe microorganism in pool of water. Water in tributary discharge directly into the pond and eventually in Ned Creek.

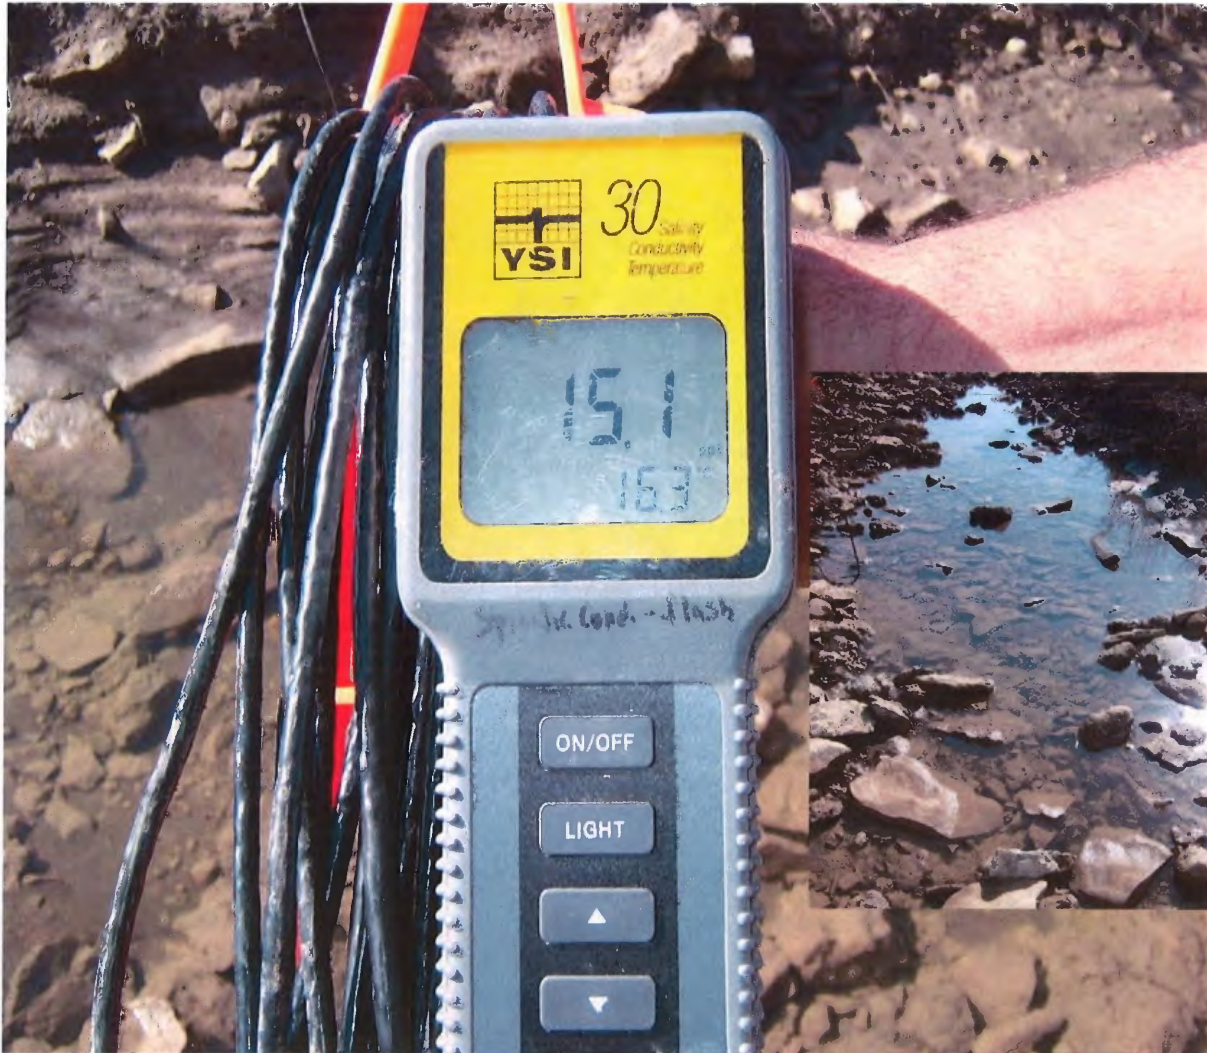
Creed Operating Facility Co., LLC Photo 19

Photo #19. Facing south east from point of entry to Need Creek and east from train rail. TSS measurement of standing fluids was 15100 ppm TSS. Did not observe microorganism in pool of water. Water in tributary discharge directly into the pond and eventually in Ned Creek.

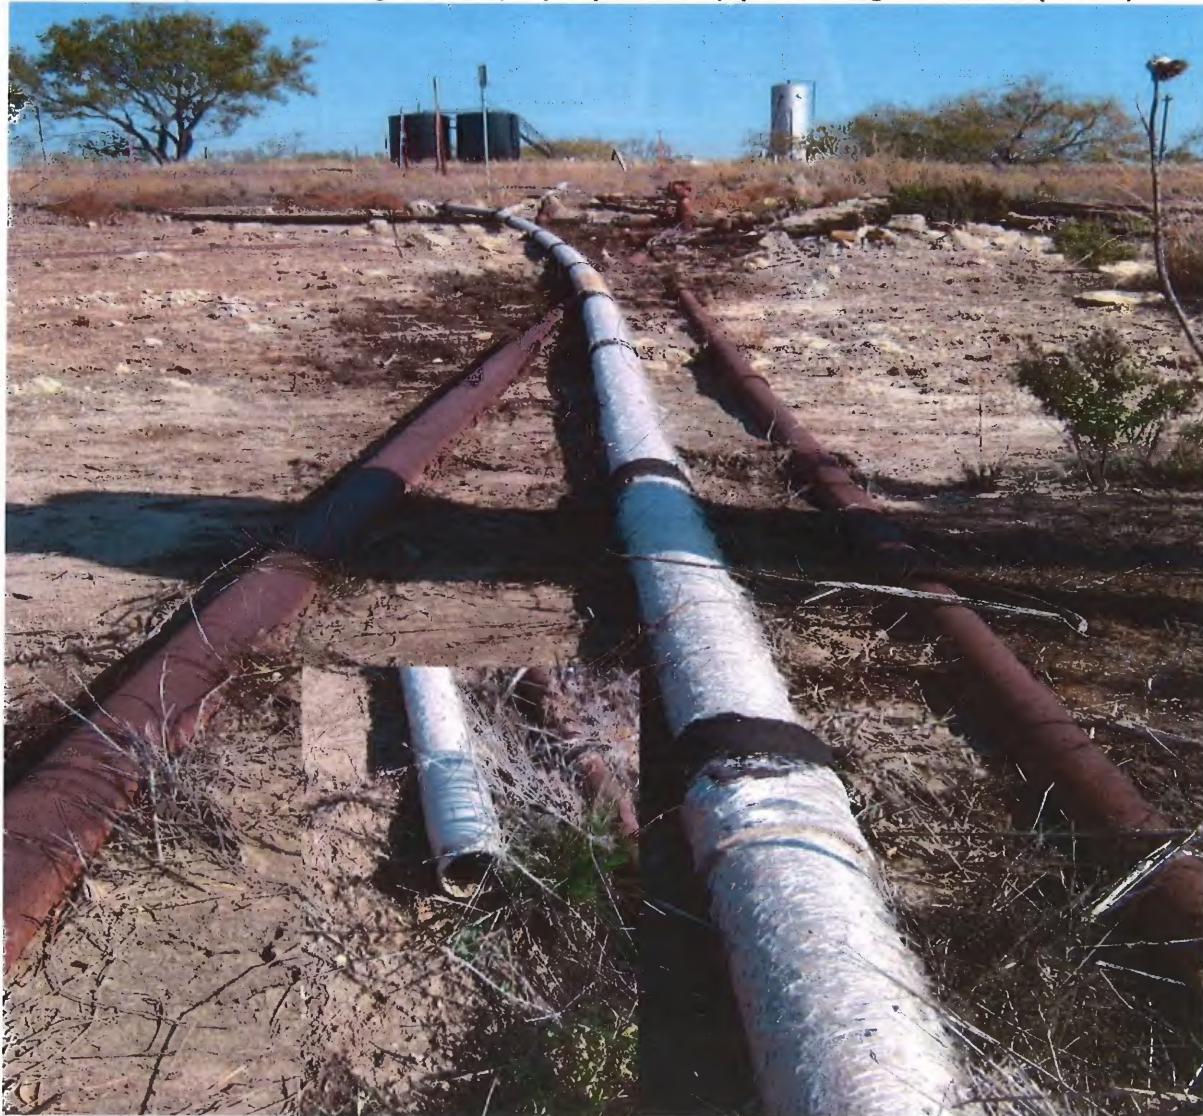
Creed Operating Facility Co., LLC Photo 20

Photo #20. Facing south east from point of entry to Need Creek and east from train rail. Observed a discharge flow paths around pipes connected to tanks (north of pies). Pipes placed improperly, open pipes discharging in open areas and tributary.

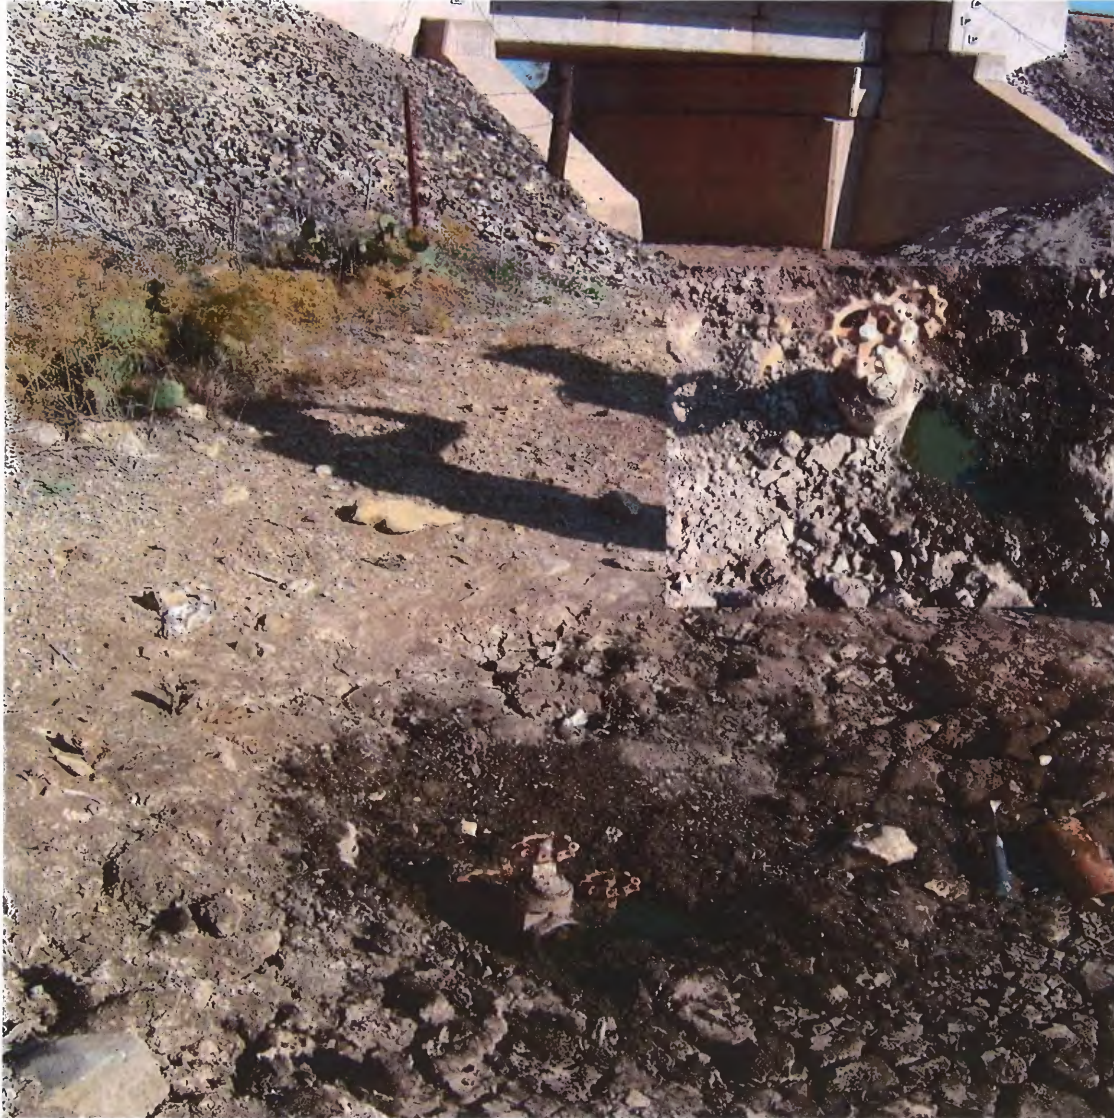
Creed Operating Facility Co., LLC Photo 21

Photo #21. Facing south east from point of entry to Need Creek and east from train rail. Observed a large discharge flow paths around exposed pipes. Flow path connect directly with tributary and eventually to Ned Creek. Pipes and valves placed improperly.

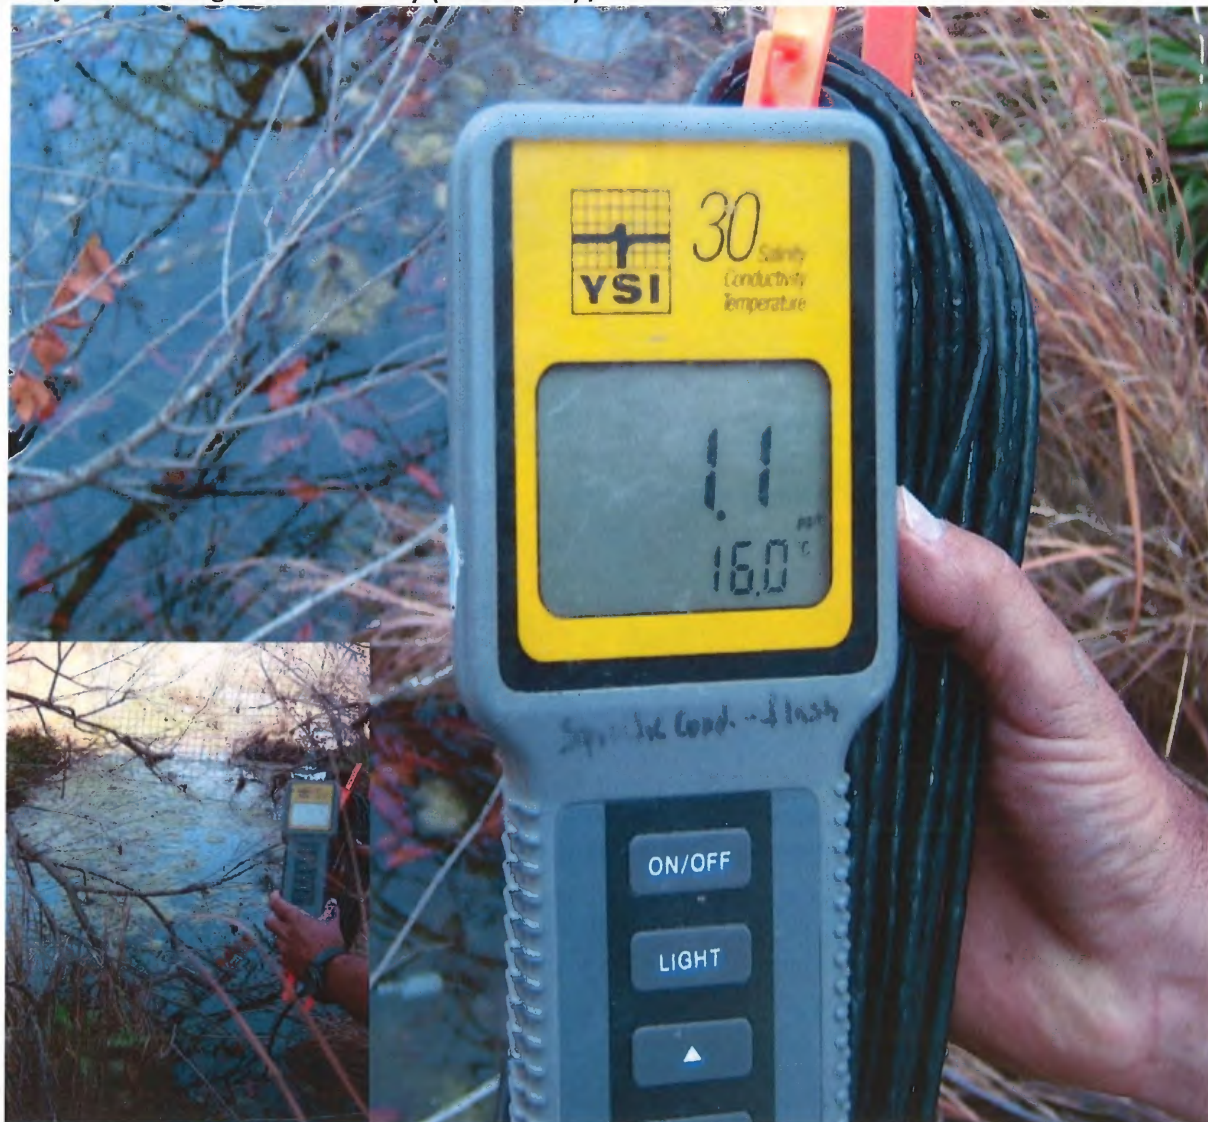
Photo #18. Facing north from tributaries and tanks. TSS measurement of standing fluids in Ned Creek was 1100 ppm TSS. Observed flow path of old discharges going to the creek. Also dead vegetation and some formations of salt crystal.

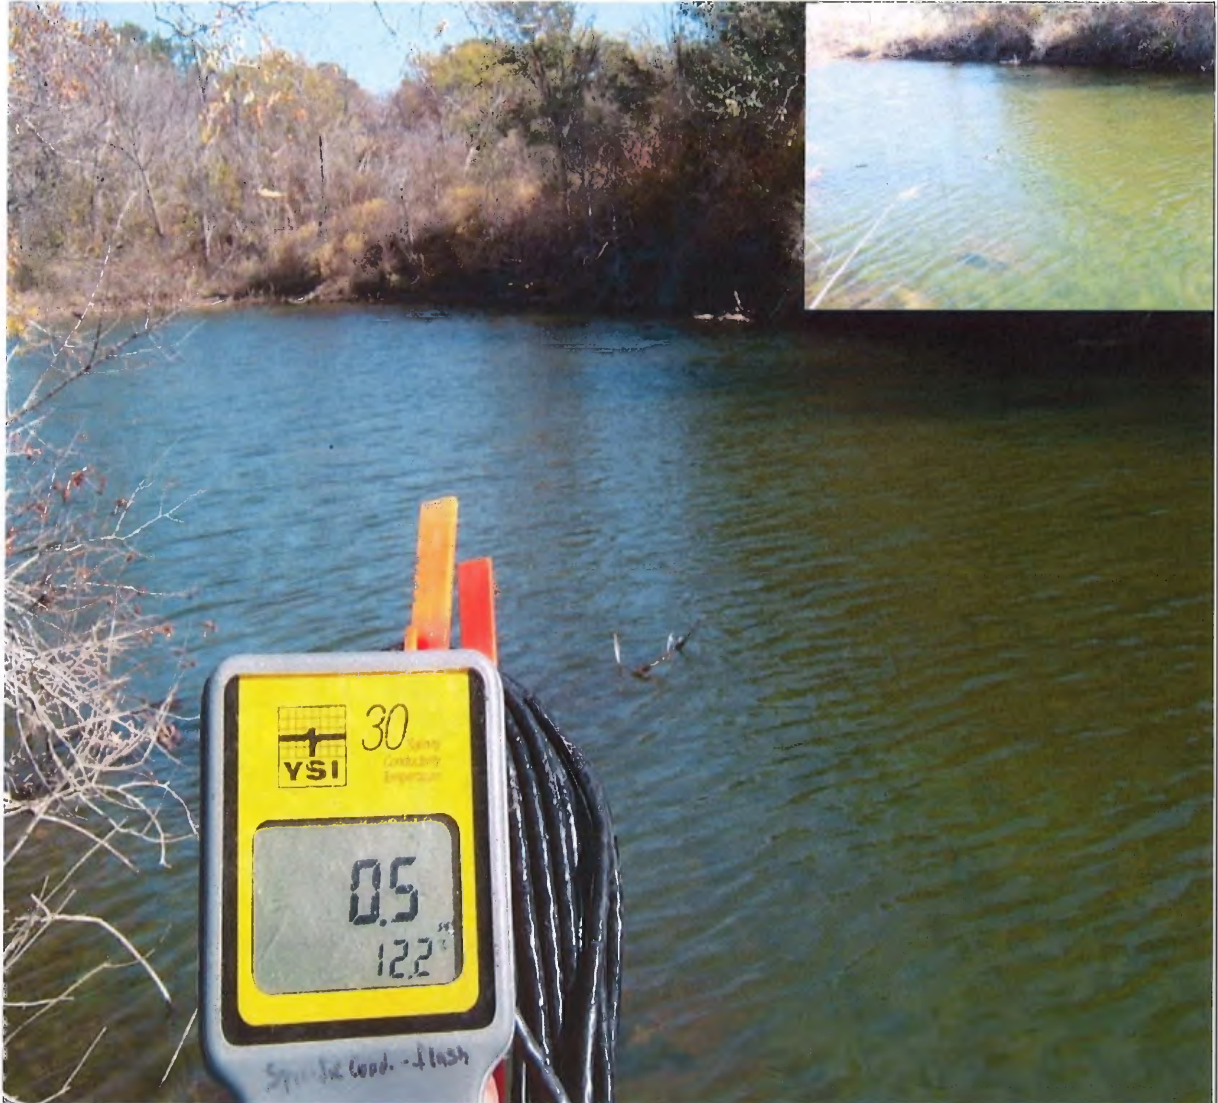
Creed Operating Facility Co., LLC Photo 19

Photo #19. Facing south west from point of entry. TSS measurement of standing fluids in Ned Creek was 500 ppm TSS. Observed organism, fish, and vegetation.

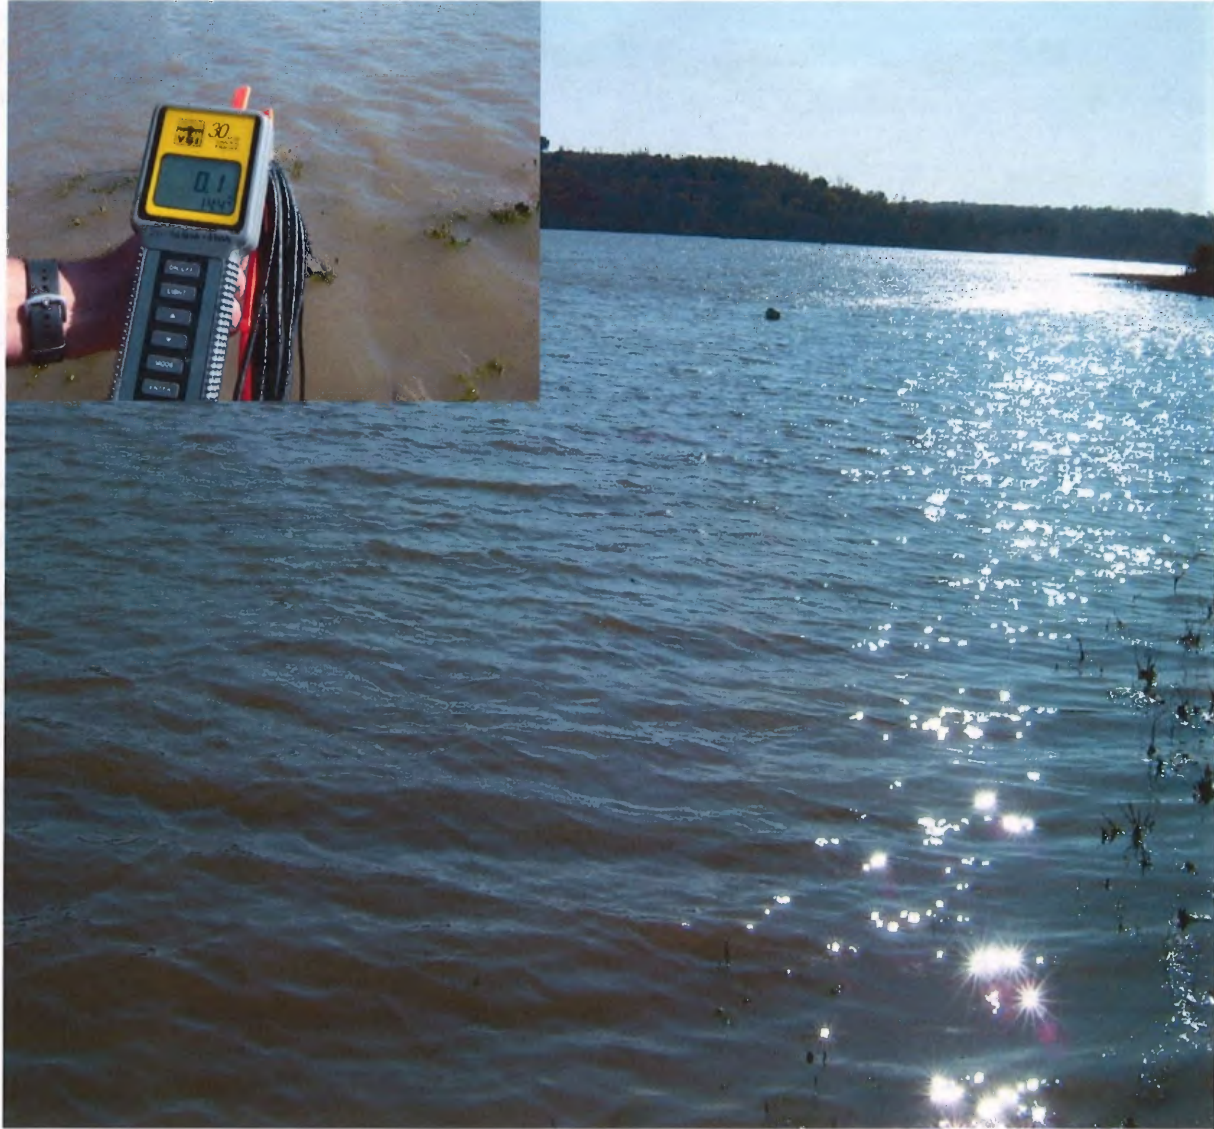
Creed Operating Facility Co., LLC Photo 19

Photo #19. Facing south west from point of entry. TSS measurement of standing fluids in Taylor Creek was 100 ppm TSS. Observed organism, fish, and vegetation. Water from lake discharge directly into Ned Creek.
